# INSPECTION REPORT

215 Elk Ridge Road, Bozeman, MT 59718

Friday, March 26, 2021

210326

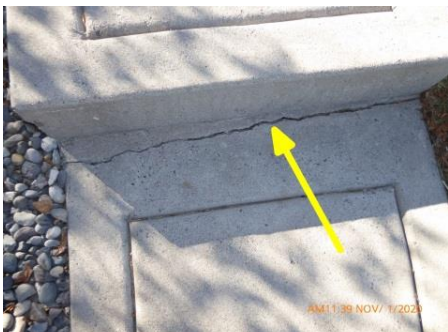
The walkway had some minor cracking. Recommend filling cracks to minimize water entering and freezing.

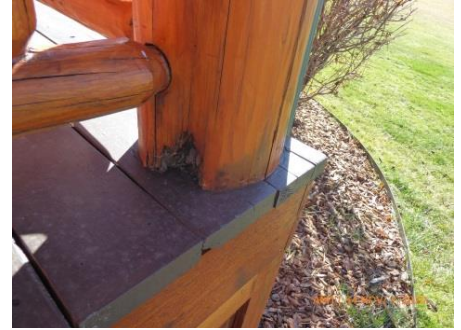
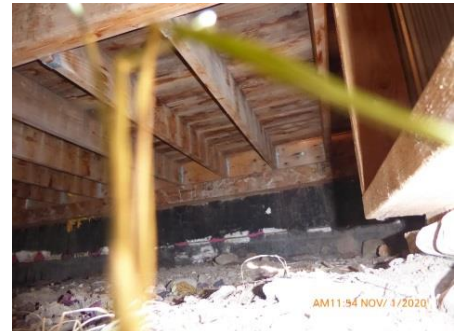
The underside of porch was not fully visible. No representation is made regarding hidden areas.  
The ledger board was not flashed. This can cause premature decay. Recommend adding flashing.

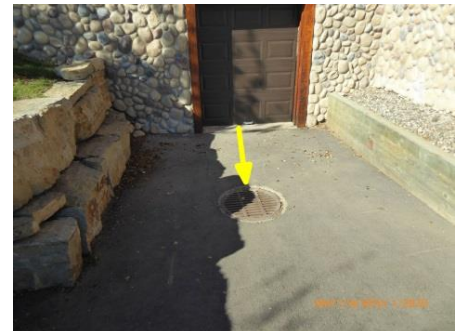
East

Negative grade areas adjacent to the foundation had a drainage system installed. The system configuration was unknown but assumed to be a French style drain. Recommend monitoring for proper drainage. No representation is made as to proper function.

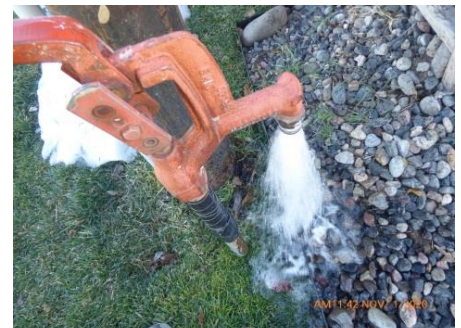
The north hose bibb was loose and should be secured.

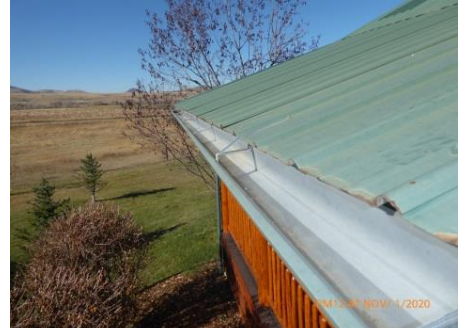
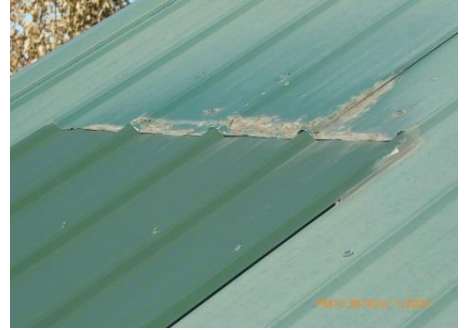
Roof was showing normal wear with minor rusting on the cut edges. I did not observe any major issues.

There was a patched area on the roof that was adequately sealed. Recommend verifying reason for the patch and obtain documentation of the work completed for warranty issues.

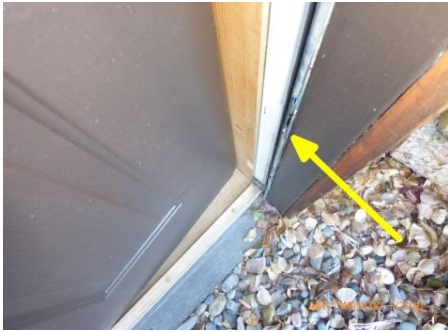
The patio door weather stripping was damaged . Recommend replacing for energy efficiency.

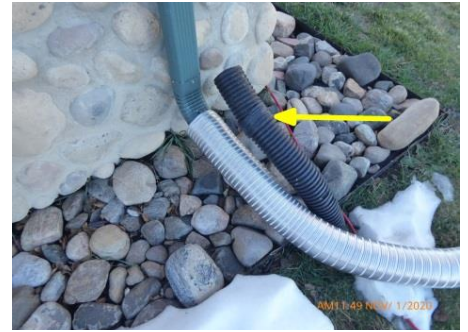
Some gutters had loose straps/spikes. Recommend securing for proper support.

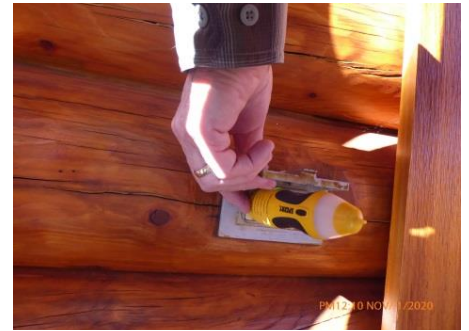
North & East exterior GFCI receptacles did not trip with test button. Recommend a licensed electrician evaluate and replace.

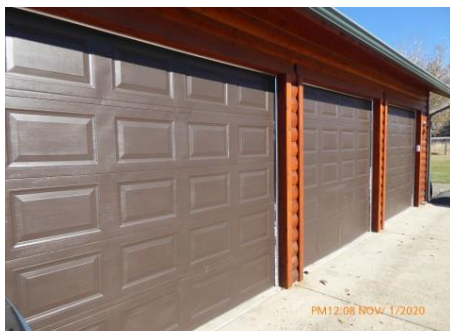
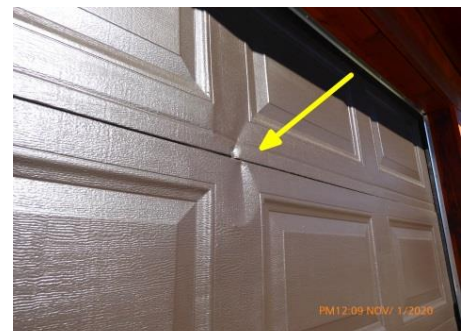
There was minor cosmetic damage on the overhead doors. Function was not affected.

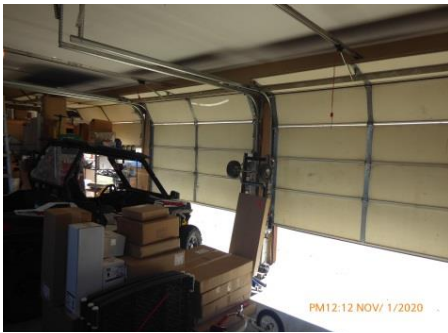
The north and south garage doors did not close properly with the automatic opener. Recommend adjustment.

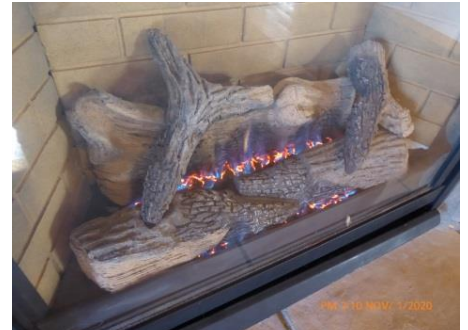
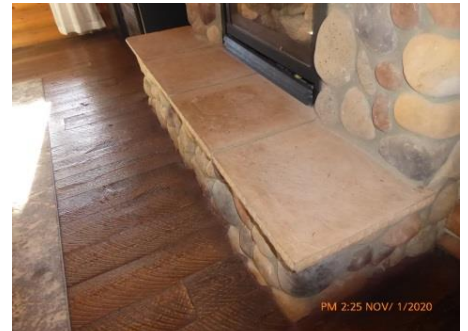
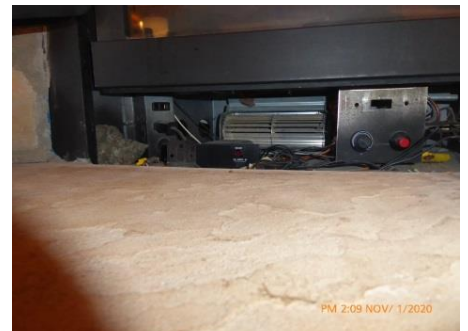
The gas fireplace was a direct vent, sealed unit. Interior components were not evaluated.  
The access door panel did not attach properly. Recommend repair or replacement.

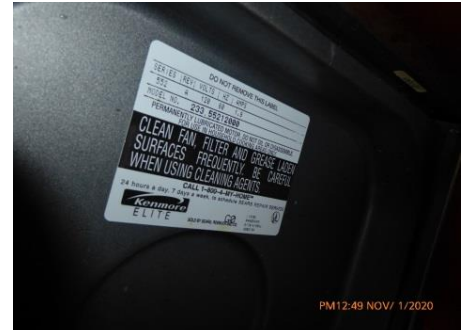
The current exhaust fan is a filtered recirculating design that vents into the kitchen rather than the exterior. Gas ranges burn natural gas producing waste products that can be hazardous to your health. Carbon monoxide is an odorless gas that is absorbed into the blood stream more quickly than oxygen. It can easily overcome a person who is unaware of the presence of these fumes.

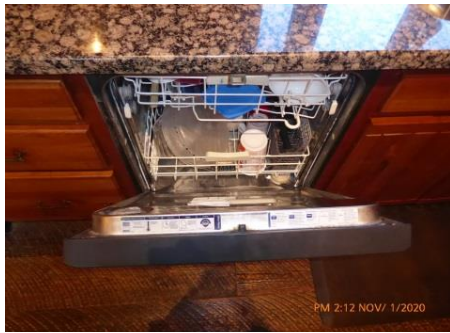
The dishwasher drain line was not looped beneath countertop. This is a cross connection concern which can siphon dirty water back into the dishwasher. Recommend looping to the highest point below counter top or provide an air gap.

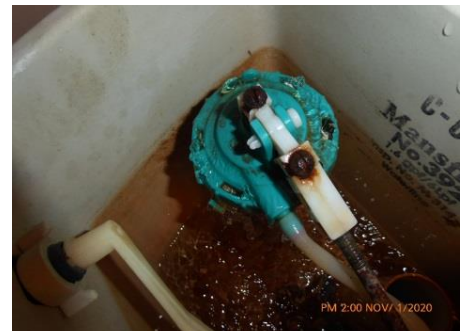
Toilet flush mechanism did not function properly. Recommend repair.

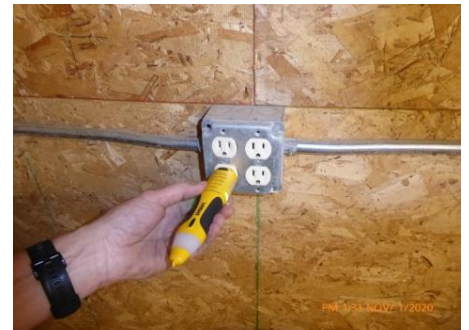
The installation of a ground fault circuit interrupter (GFCI) is recommended in unfinished basements and damp locations. A GFCI offers increased protection from shock or electrocution.

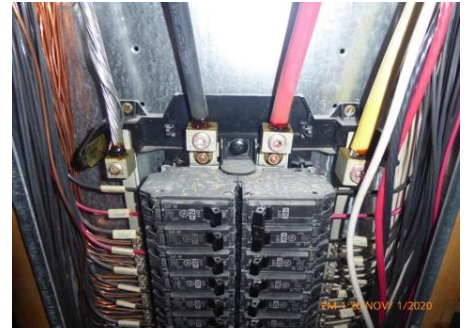
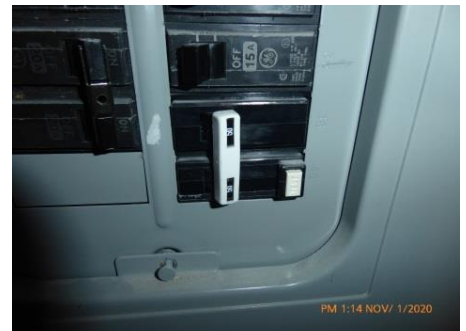
The sub-panel was missing screws. Recommend adding for protection.

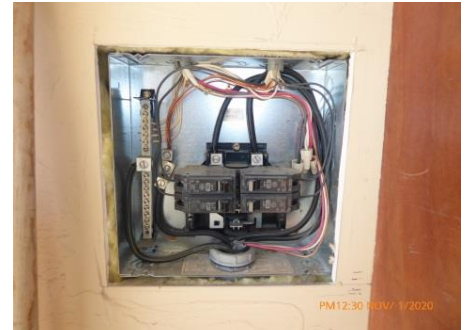
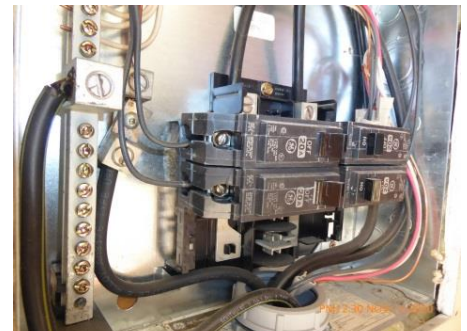
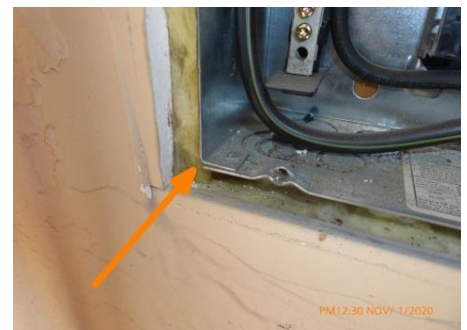
Panel Did Not Fit Flush
