# INSPECTION REPORT

215 Elk Ridge Road, Bozeman, MT 59718

Friday, March 26, 2021

210326

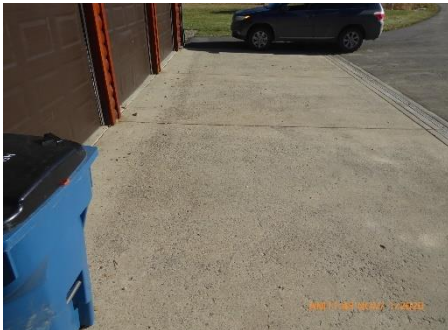
Marginal

Recommend filling/sealing cracks to minimize water entering and freezing.

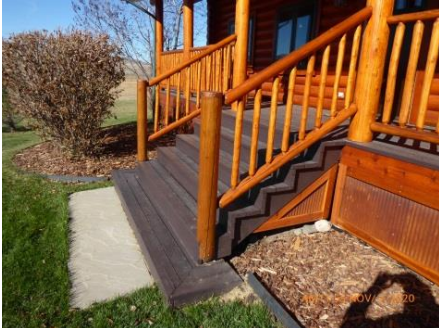
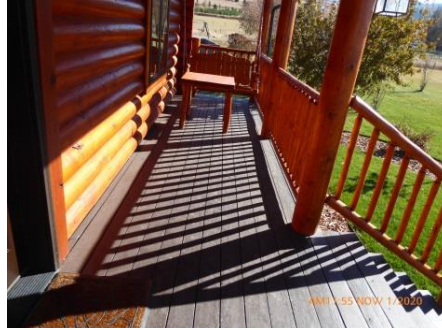
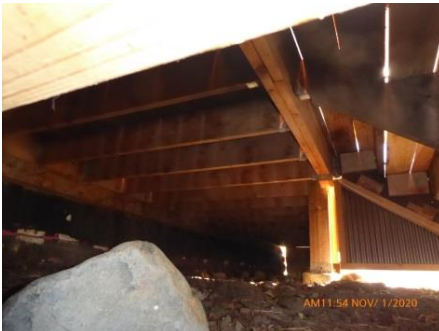
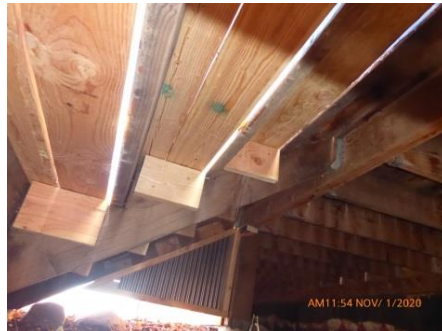
The underside of porch was not fully visible. No representation is made regarding hidden areas.  
The ledger board was not flashed. This can cause premature decay. Recommend adding flashing.

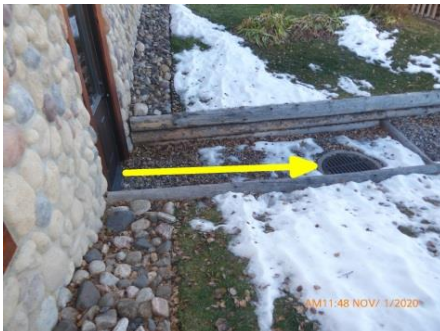
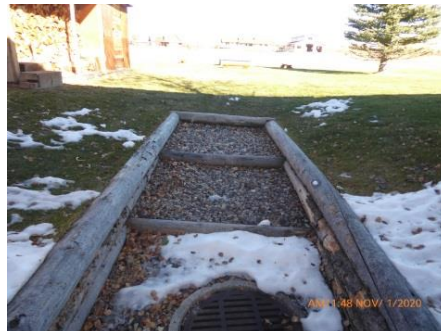
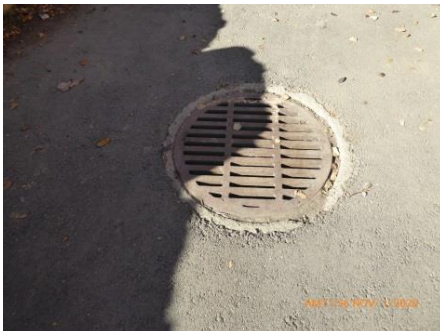
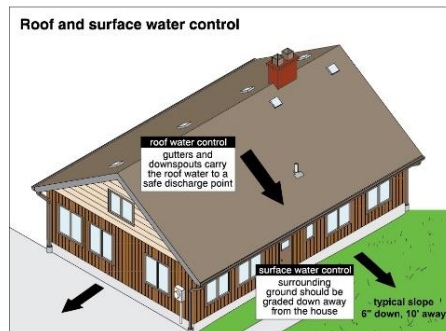
East

Negative Grade

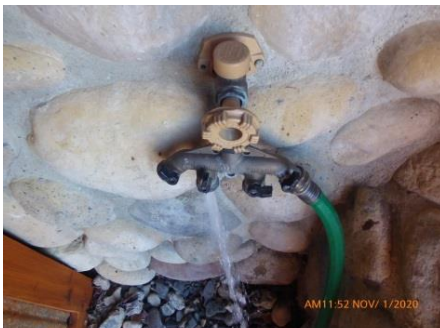
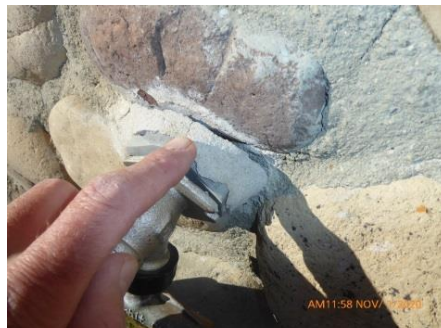
Well Hydrant

The north hose bibb was loose and should be secured.

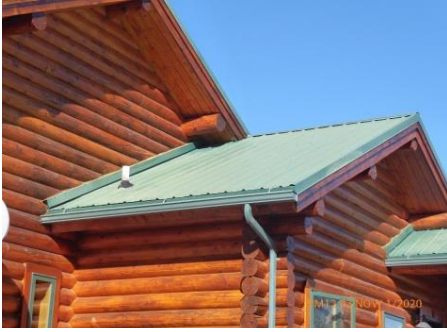
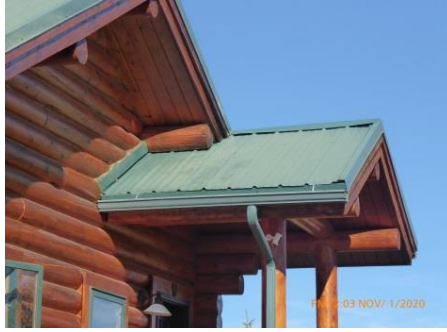
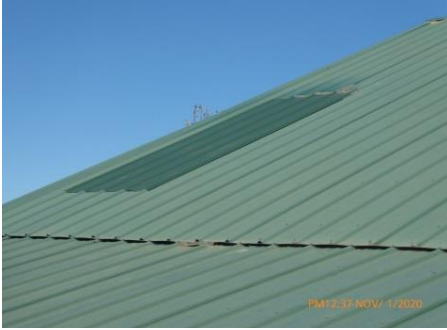
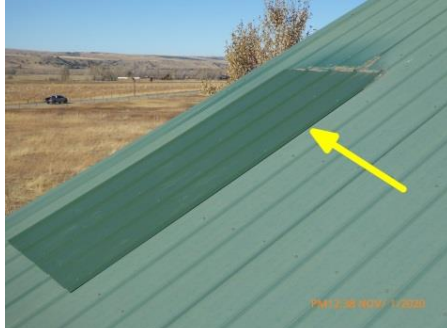
Roof was showing normal wear with minor rusting on the cut edges. I did not observe any major issues.

There was a patched area on the roof that was adequately sealed. Recommend verifying reason for the patch and obtain documentation of the work completed for warranty issues.

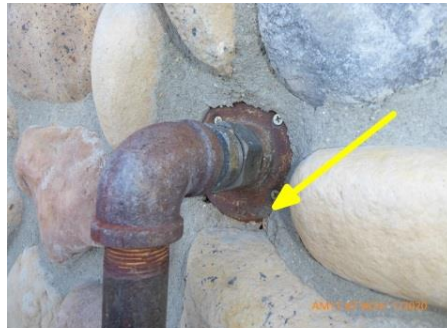
Seal all penetrations

Recommend caulking around the following: (Avoid spray foam if exposed to UV light.)

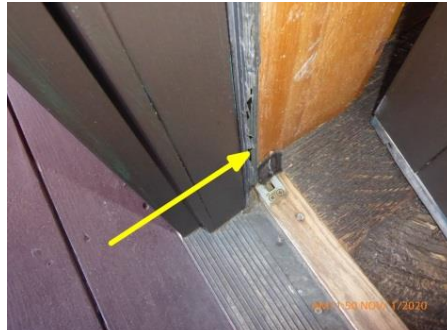
The patio door weather stripping was damaged . Recommend replacing for energy efficiency.

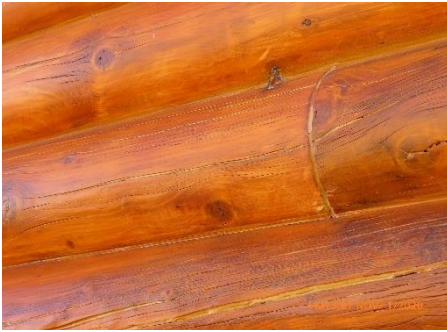
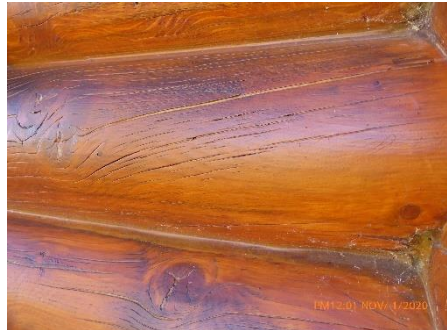
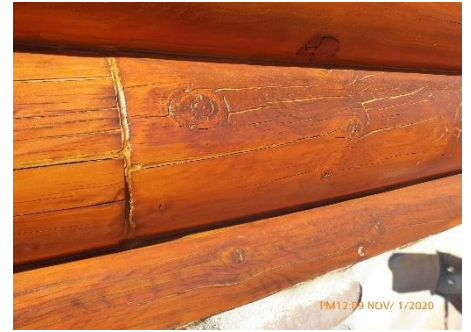
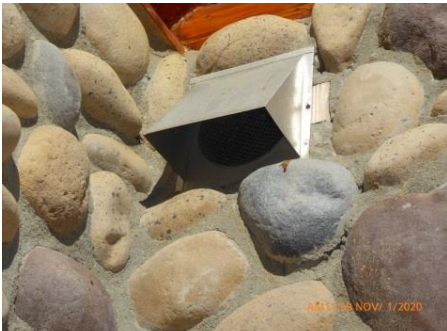
A log home structure must be evaluated every year to monitor for weathering and separation. Recommend sealing cracks on the upper surfaces of logs which do not allow water to drain effectively . Staining on a regular basis with high quality materials is also necessary to ensure a long life. The exterior wood finish coating should be identified from the seller to ensure that the chemical compound and manufacturer's recommendations are followed when refinishing in the future.

Recommend caulking around the following: (Avoid spray foam if exposed to UV light.)

- Trim
- Corners
- Utility Penetrations
- Doors/Windows as recommended by manufacturer

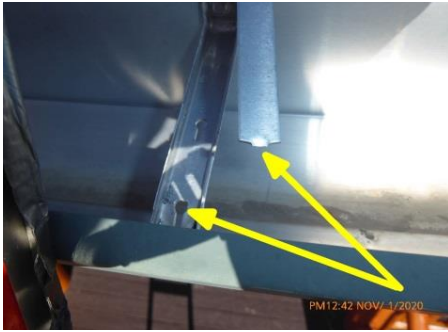
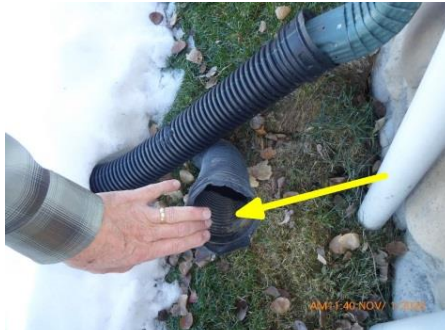
Some gutters had loose straps/spikes. Recommend securing for proper support.

Some downspouts discharge underground. Unable evaluate below ground configuration and termination point. No representation is made. Downspouts that discharge below grade level should be monitored. If they are ever suspected to be clogged or disconnected below grade, they should be redirected to discharge at least five (5) feet from the building. Foundation leakage adjacent to a downspout is an indication of a problem below grade.

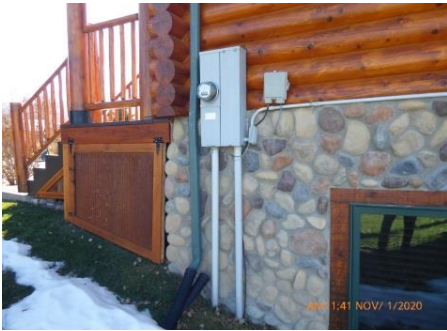
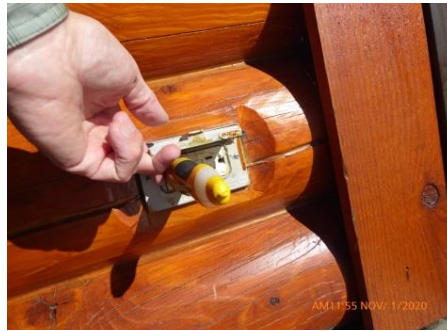
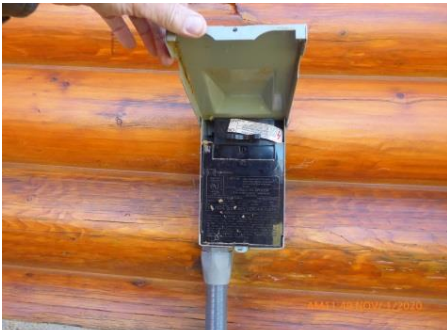
North & East exterior GFCI receptacles did not trip with test button. Recommend a licensed electrician evaluate and replace.

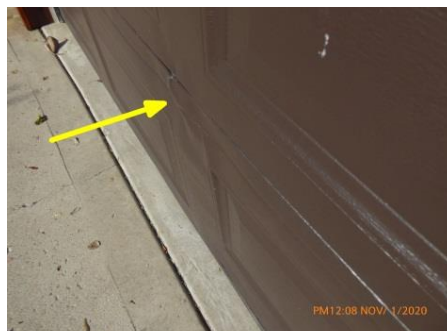
There was minor cosmetic damage on the overhead doors. Function was not affected.

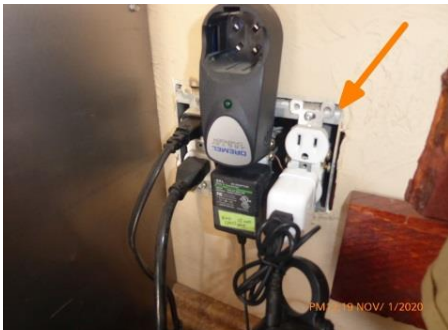
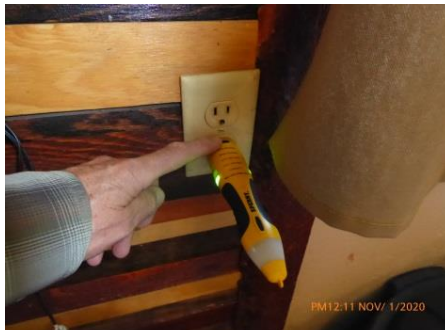
There was not GFCI protection in garage. The installation of ground fault circuit interrupter protection is recommended in garage locations.

A receptacle did not have a cover. Recommend adding for safety from electric shocks.

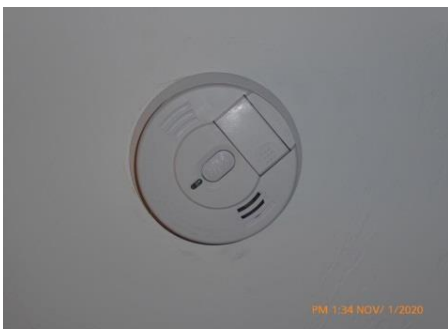
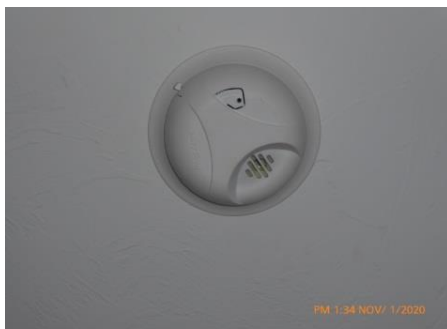
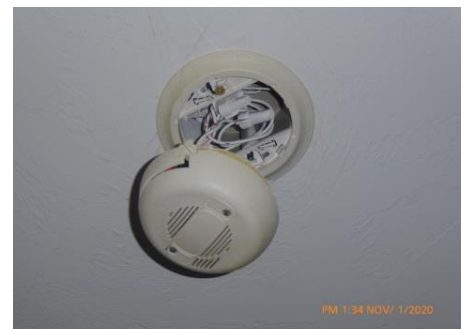
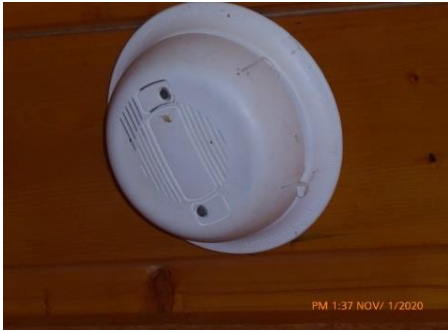
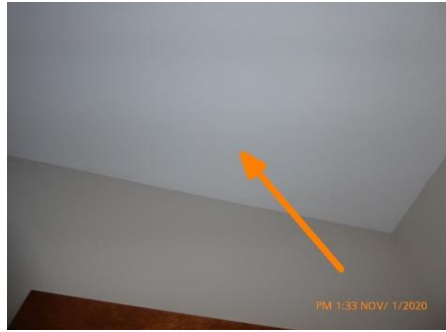
At least one smoke alarm was not observed where needed. Recommend additional devices be installed to State of Montana recommendations. For enhanced safety it is recommended that a photoelectric smoke alarms be used.

At least one smoke alarm did not signal when test button was pressed. Recommend repair or replacement with a photoelectric smoke alarm.

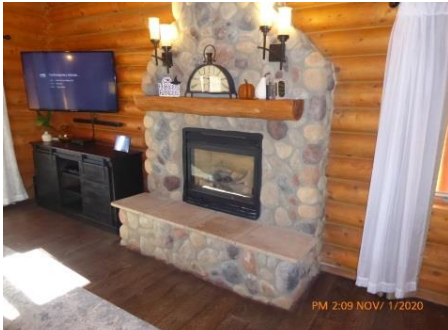
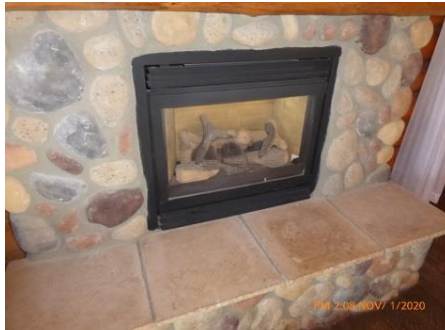
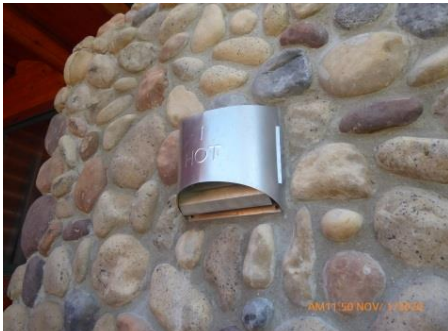
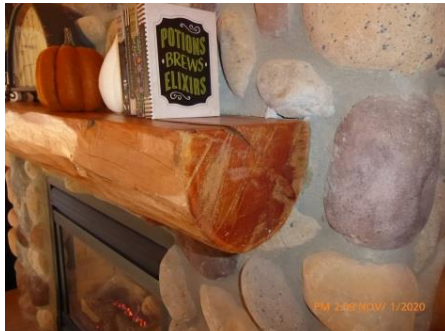
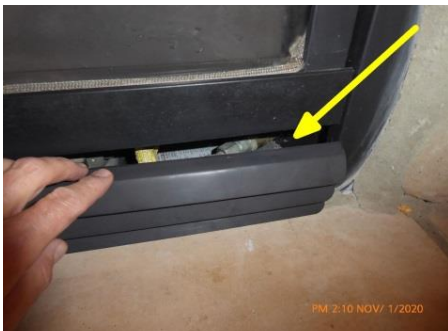
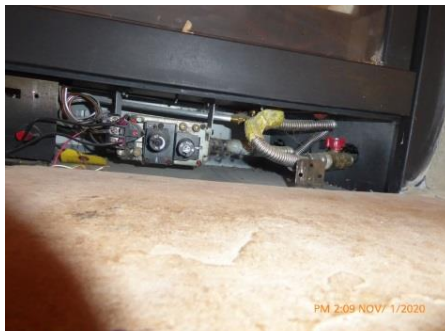
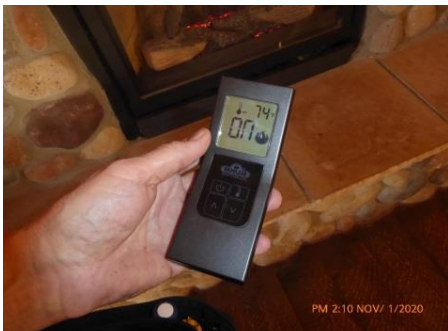
The gas fireplace was a direct vent, sealed unit. Interior components were not evaluated.  
The access door panel did not attach properly. Recommend repair or replacement.

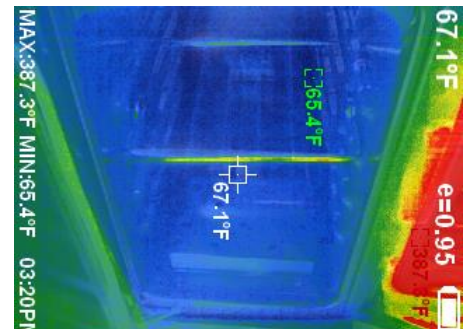
Auxiliary oven thermal image

The auxiliary oven did not operate properly. Recommend investigation and repair if necessary.

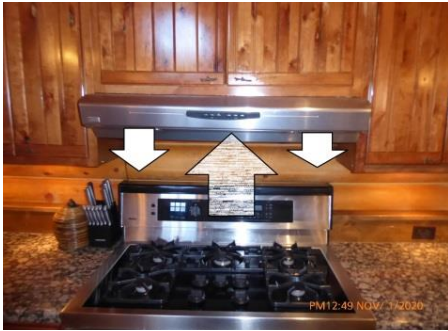
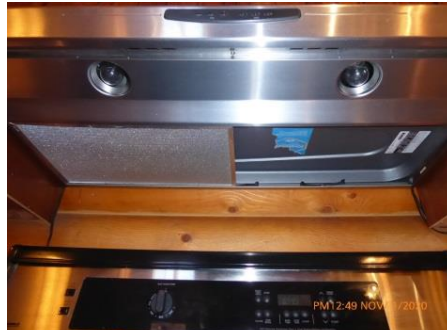
The current exhaust fan is a filtered recirculating design that vents into the kitchen rather than the exterior. Gas ranges burn natural gas producing waste products that can be hazardous to your health. Carbon monoxide is an odorless gas that is absorbed into the blood stream more quickly than oxygen. It can easily overcome a person who is unaware of the presence of these fumes.

To reduce fumes from gas ranges, open windows slightly to allow the flow of fresh air for ventilation. Install carbon monoxide alarms in your home to alert you to fume problems that may arise from the use of gas ranges and other appliance. The best solution is to install a vent to the exterior. Recommend removing filter and washing periodically to remove grease and particulates.

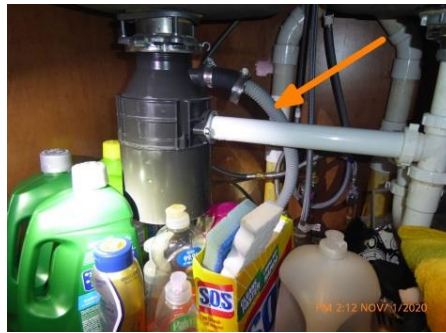
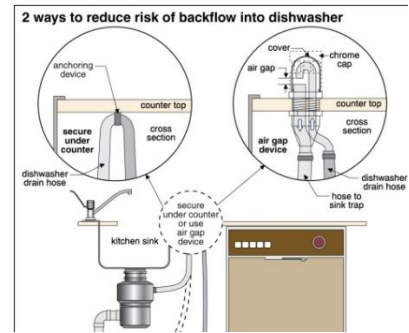
The dishwasher drain line was not looped beneath countertop. This is a cross connection concern which can siphon dirty water back into the dishwasher. Recommend looping to the highest point below counter top or provide an air gap.

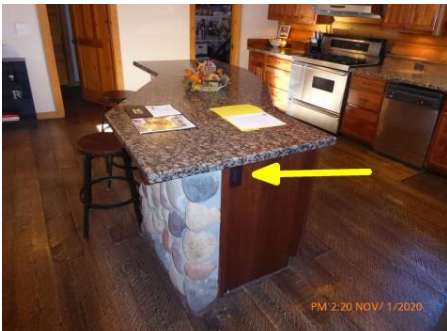
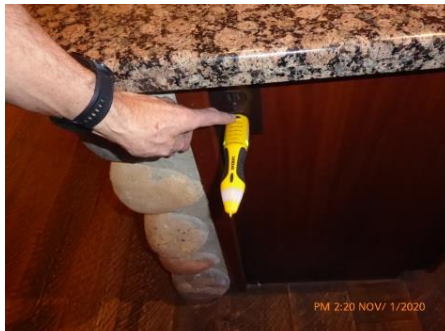
The kitchen had GFCI protected receptacles within 6' of water. Consider adding protection for garbage disposal and dishwasher circuits at a minimum and all servicing countertop surfaces. A GFCI offers increased protection from shock or electrocution.

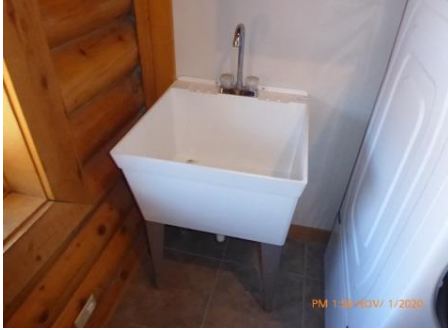
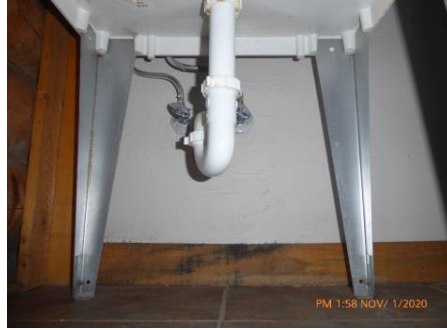
For enhanced safety it is recommended that Laundry Areas have GFCI protection regardless of presence of a sink or distance from same.

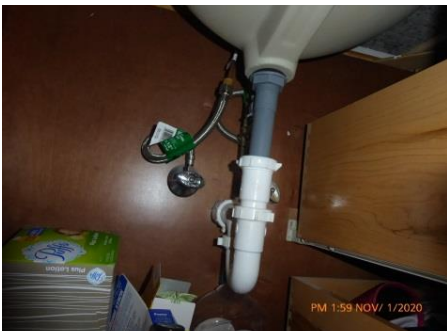
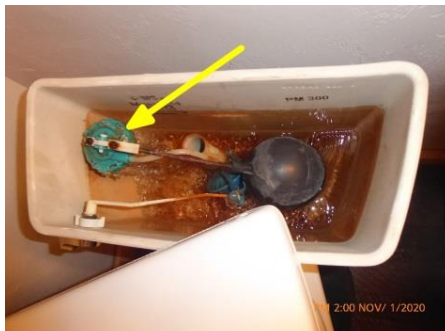
Toilet flush mechanism did not function properly. Recommend repair.

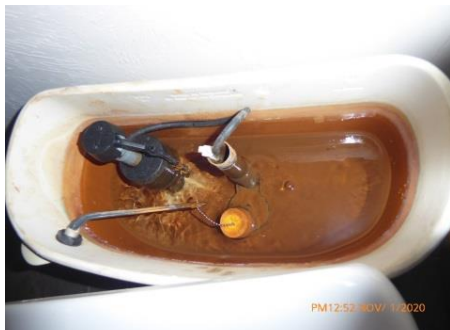
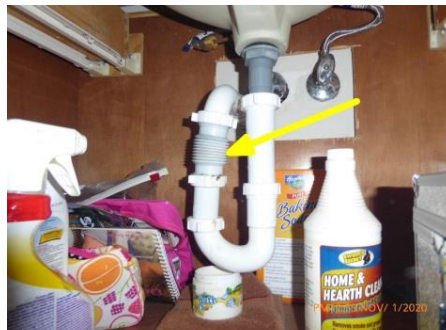
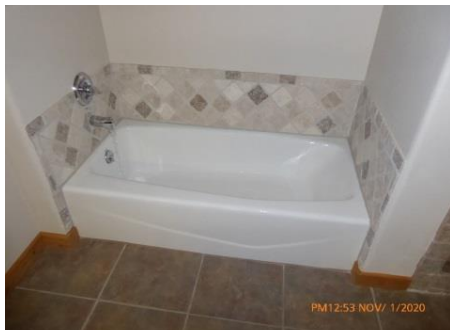
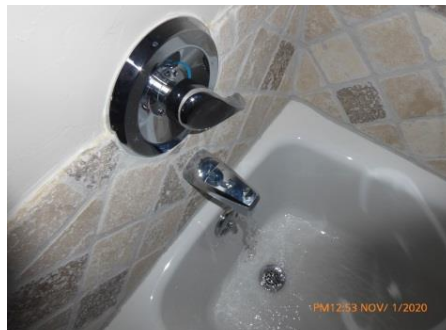
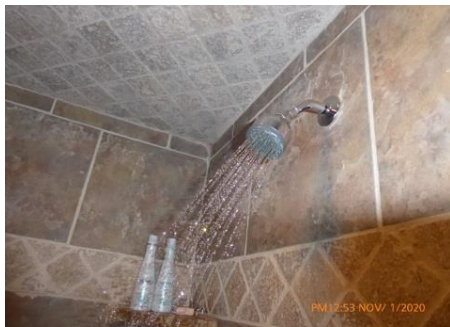
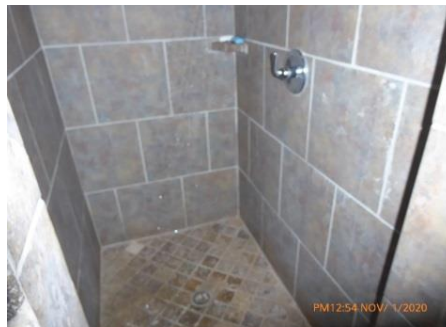
Flex pipe used for drain. This can cause premature clogging. Recommend straight tail piece to trap.

An exhaust fan was not installed in bathroom. Recommend installing to reduce moisture buildup from showers/baths.

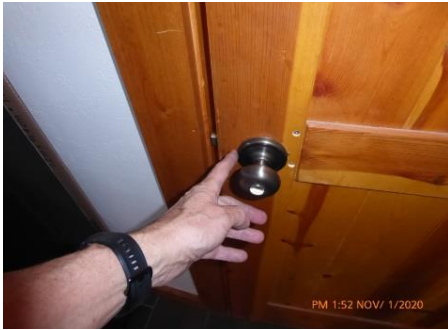
A closet door did not latch properly. Recommend repair.

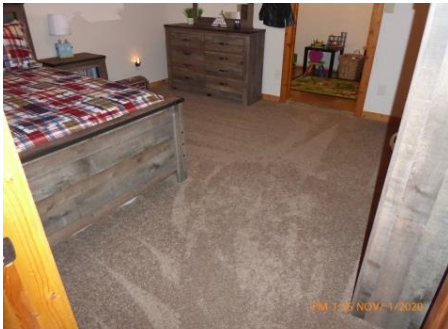
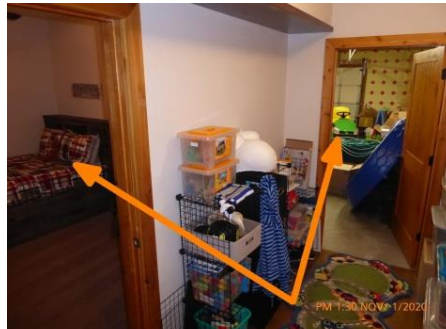
Note: The Southeast basement bedroom did not have windows but had a secondary exit via a door to the unfinished basement area. The access to this area means that flammable and volatile materials should not be stored in that area due to fire and fumes infiltration concerns.

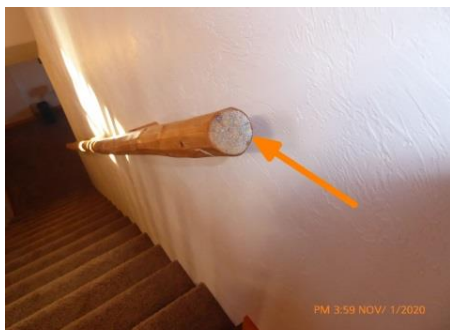
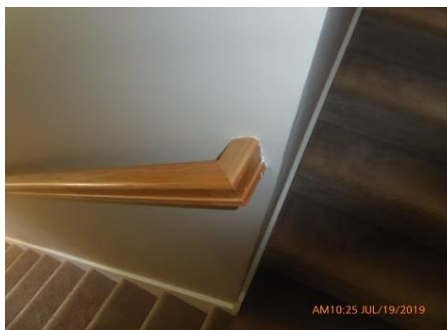
Return Example

A handrail return is recommended to prevent catching of clothing and loose articles while using stairs. Recommend installing for safety.

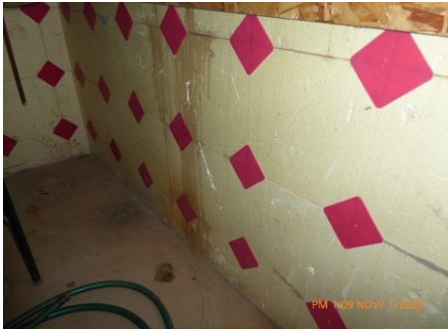
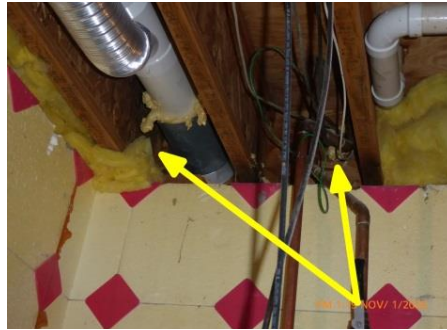
Rim joist insulation was missing in certain areas. Recommend adding to increase energy efficiency.

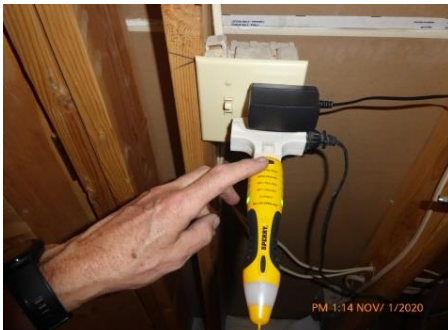
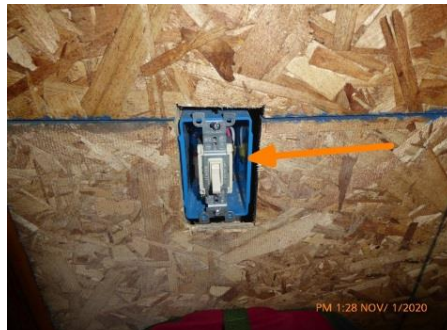
The installation of a ground fault circuit interrupter (GFCI) is recommended in unfinished basements and damp locations. A GFCI offers increased protection from shock or electrocution.

Missing receptacle and switch box cover plates should be installed for safety.

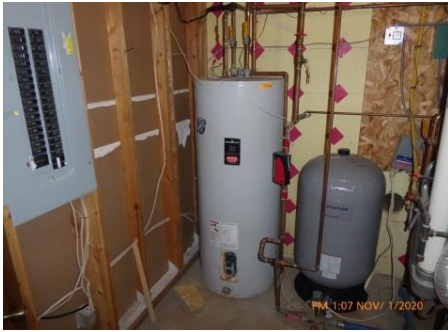
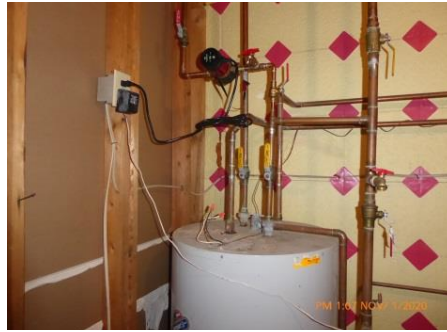
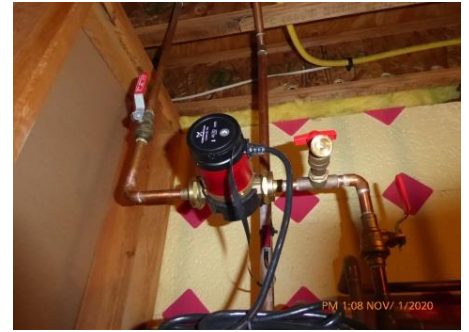
Circulation Pump

The home had a hot water circulation pump installed. This system provides hot water to taps very quickly. Recommend familiarization regarding controls and maintenance.

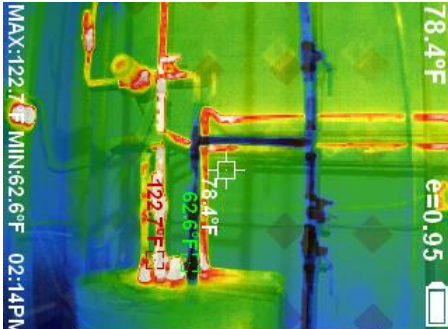
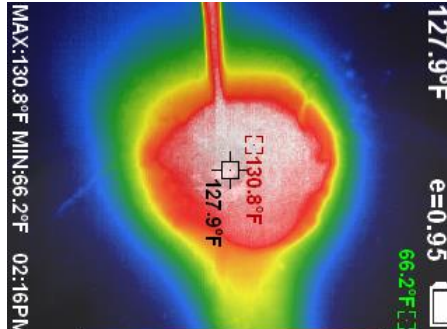
Measured Water Temperature

High water temperature was measured at faucets. Recommend reducing it to 122° to prevent scalding.

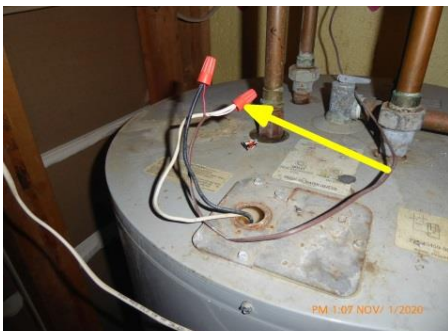
Low Voltage Wires

Low voltage control wires were not properly encased within the unit. Recommend proper installation to prevent disconnection or damage.

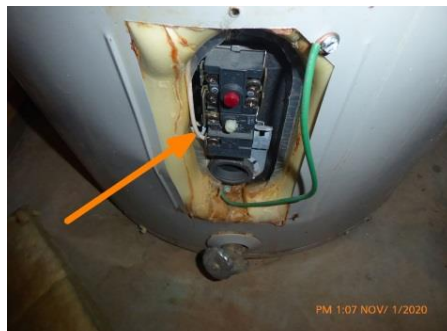
High Voltage Access Panel Removed by Others

A high voltage access panel was not installed. This is a safety hazard. Recommend replacing.

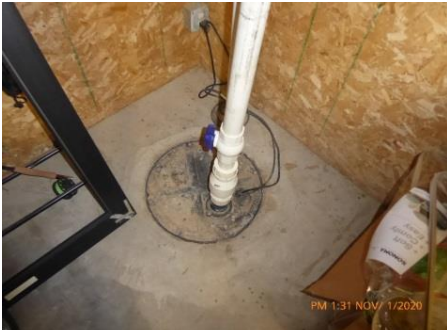
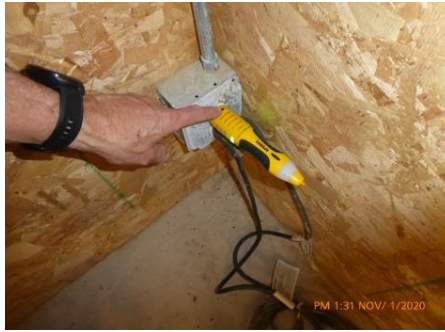
The sump Pump was on Duplex receptacle which was not GFCI protected. Recommend:

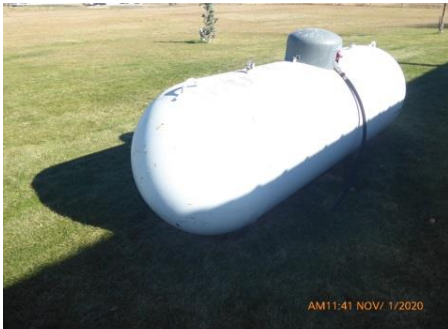
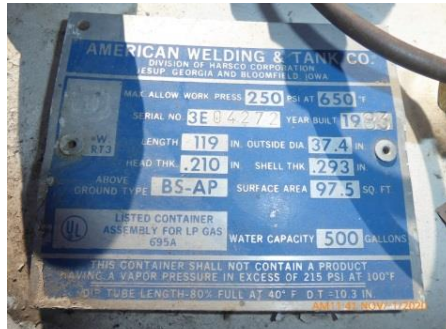
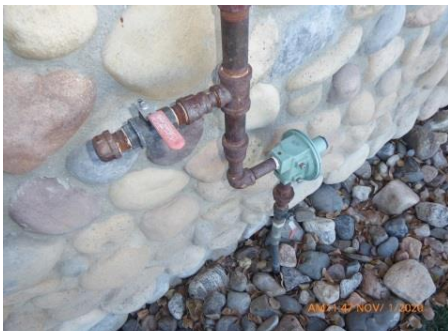
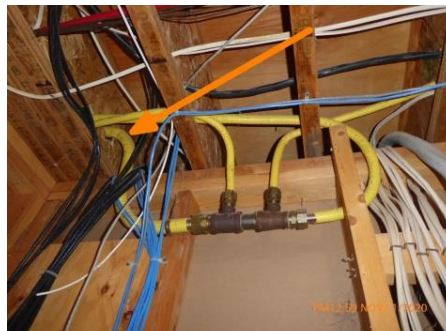
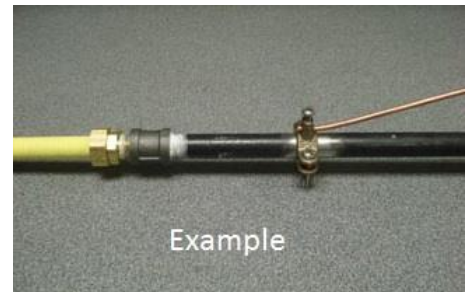
I was unable to verify if the Yellow Corrugated Stainless-Steel Tubing (CSST) was bonded. Recommend verifying requirements and if needed, a licensed electrician should bond gas line to the home's grounding system up stream of CSST for safety from lightning strike.

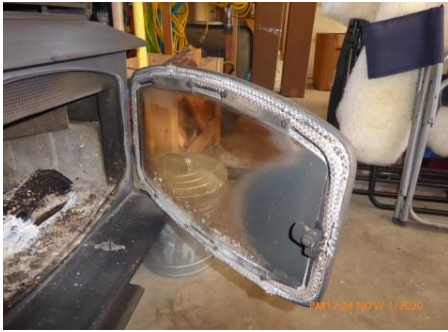
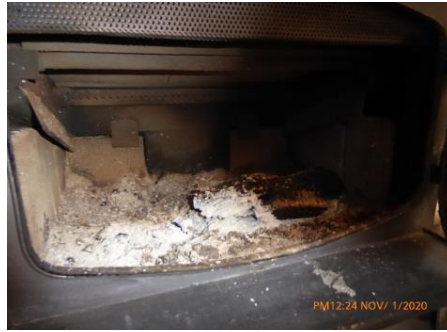
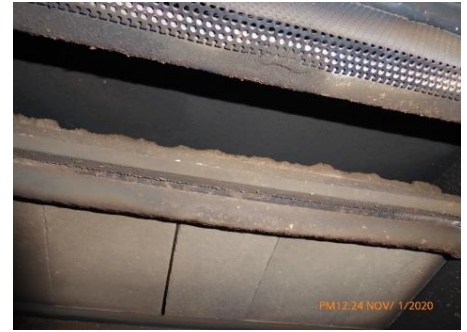
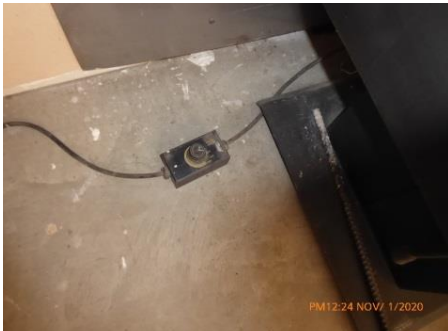
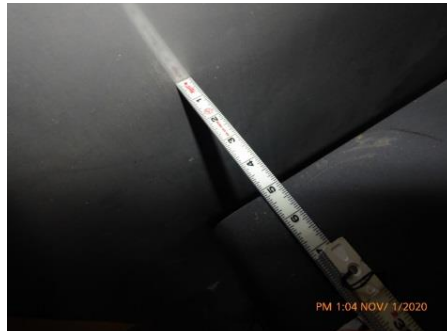
The clearance label of the garage wood stove was not visible due to wall clearance. I was unable to verify if the wood stove clearances were satisfactory. Recommend that home buyer fully verify wood stove specifications and operation based on manufacturer's specifications.

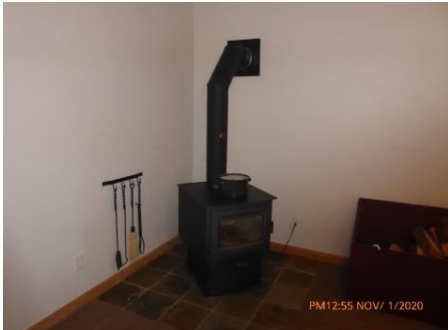
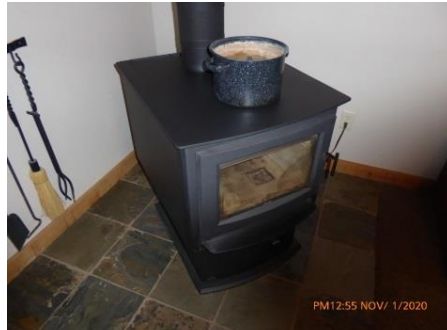
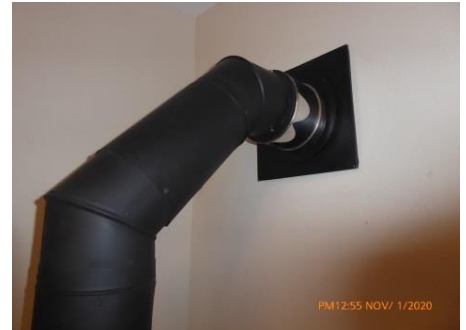
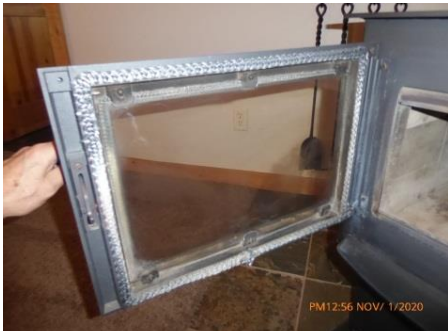
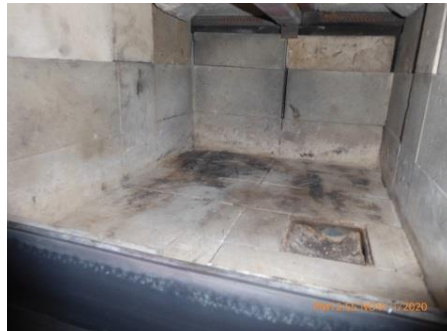
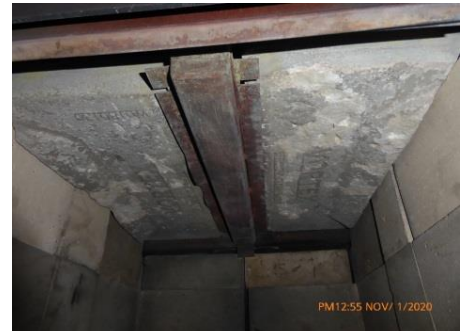
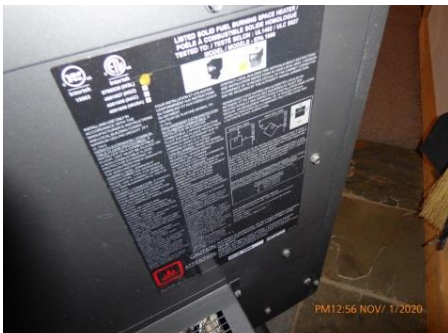
The clearance label of the garage wood stove was not visible due to wall clearance. I was unable to verify if the wood stove clearances were satisfactory. Recommend that home buyer fully verify wood stove specifications and operation based on manufacturer's specifications.

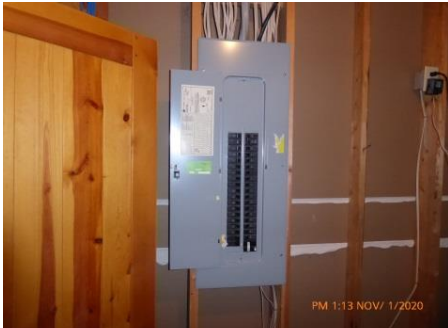
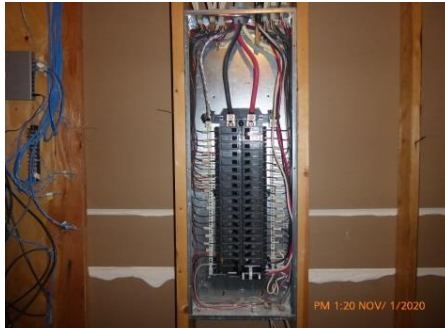
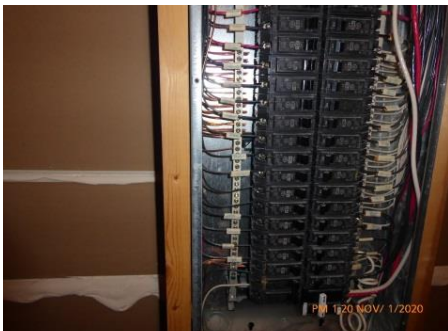
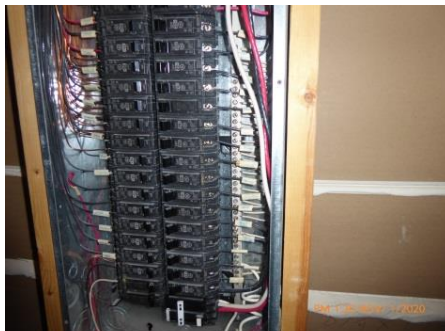
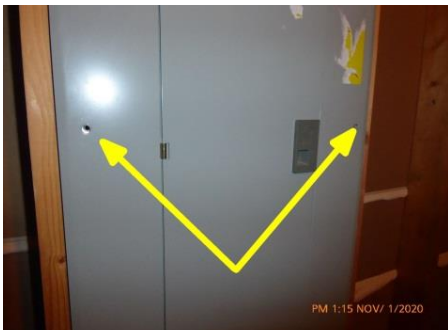
The sub-panel was missing screws. Recommend adding for protection.

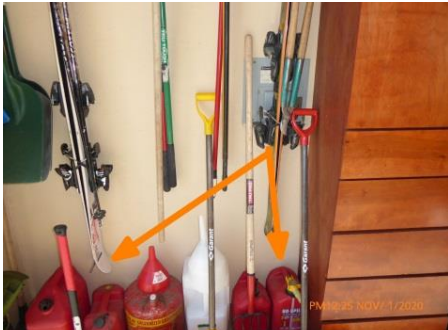
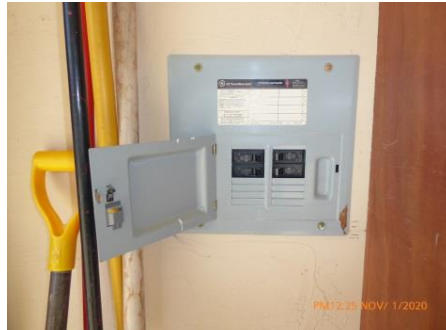
Panel Did Not Fit Flush

The panel cover did not fit flush. This is a safety hazard as combustible materials will be exposed if arcing occurs. This is also a concern as the gaps near the breakers are not sealed adequately. Recommend modification with an extension frame or other methods.

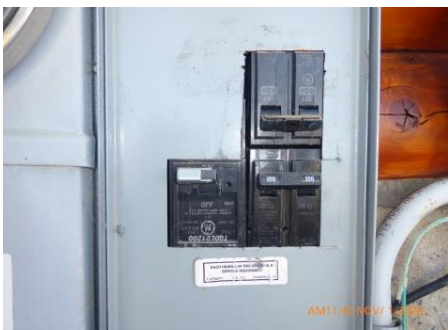
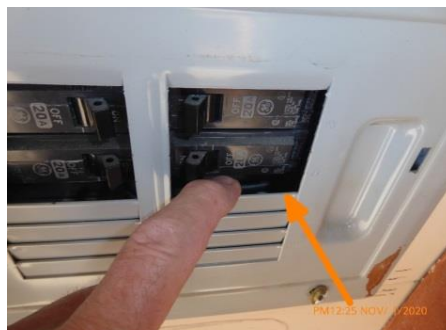
Gasoline stored in close proximity of a sub panel is not recommended due sparking concerns. Recommend repositioning the gasoline.
